## **Technological aspects of construction molybdenum high gradient X-band standing wave accelerating structures**

### **Abstract**

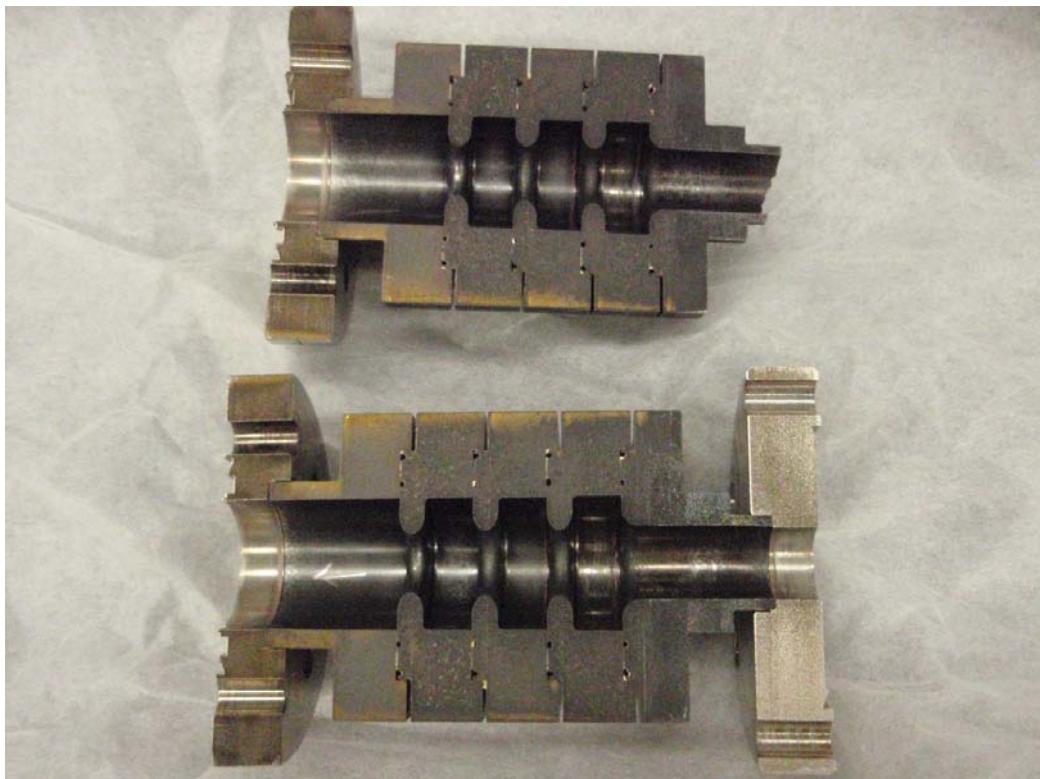
After being removed from high gradient test area, the structure was sectioned along the axis at SLAC klystron lab to allow for internal inspection [9]. The structure was first split into 2 pieces using EDM (Electrical Discharge Machining). One of the half pieces was split again. On the initial sectioning, one of the molybdenum “extension tubes” failed adjacent to the SST flange braze, as shown in figure 1. Note that the arrow shown in the image was observed by the machinist, not added during the cutting.

Fig 1 Moly structure was split up into 2 pieces using EDM.

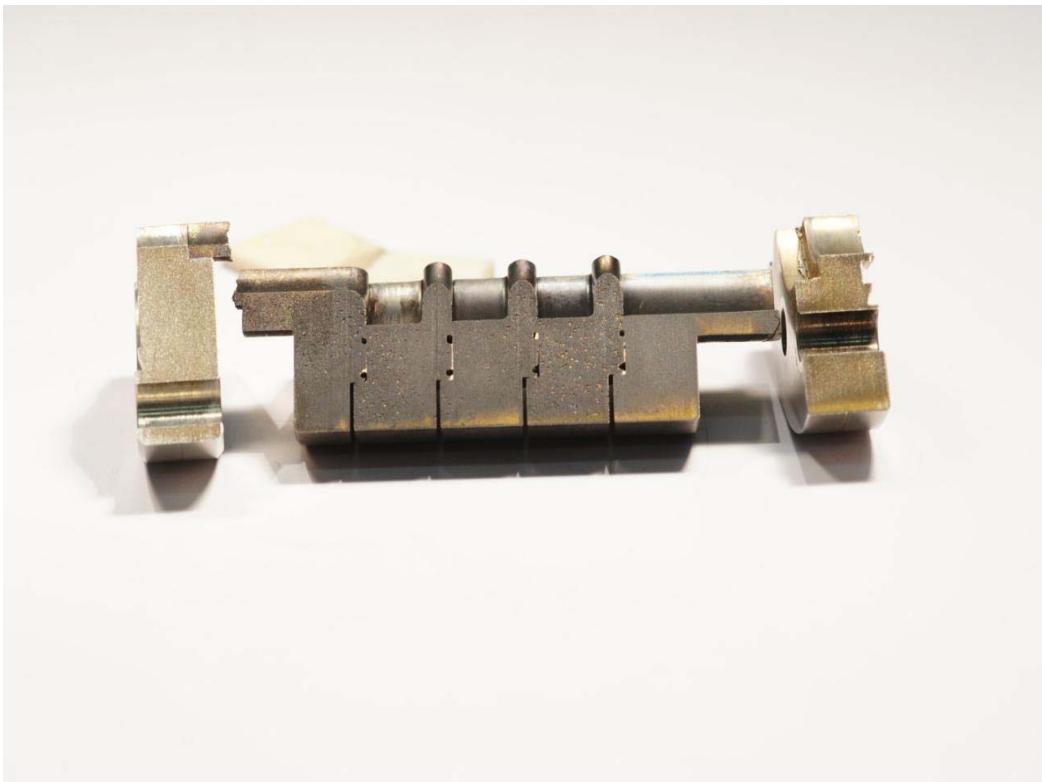
When one of the sections was cut again [also by EDM both flanges on one of the pieces (a 1/4 section of the whole) detached as shown in figure 2. It appears that in the case where the joint failed in the braze area (see figure 3), the molybdenum cylinder wall was thick enough to withstand the differential expansion forces but that the braze joint was not. In the case of the other end, the thinner molybdenum wall was insufficient to withstand the forces applied (see figure 4). On closer inspection we found that the joint was not completely filled with alloy which would result in uneven loading and increased/concentrated stress. We think that this increased stress between SST and molybdenum may have contributed to both failures. We speculate that during braze cycle, a large radial gap between SST flange and molybdenum appeared due to larger thermal expansion of the SST flange. This gap may have caused the non-uniform filling of the joint by the alloy.

Fig 2 When one of the sections was cut again (also by EDM) both flanges on one of the pieces (a 1/4 section of the whole) detached as shown

A possible solution that may reduce stresses caused by difference of thermal expansions could make use of an additional flexible part (in this case a cylinder) between molybdenum structure and SST flange. This thin-wall cylinder could be made out of stainless steel, CuNi, or copper and it should be properly designed to accommodate stresses created during the brazing. The joint between this flexible cylinder and molybdenum could be made with a groove that locks outside diameter of the cylinder as shown on figure 5a. This joint has to be properly designed to have adequate clearance when the parts are heated during the brazing. The design should also take into account thermally induced forces between the locking groove and the cylinder. The joint can be strengthened by locking not only outside diameter of the flexible cylinder, but also its inside diameter as shown on figure 5b. This, for example could be done for the flexible cylinder with large diameter.

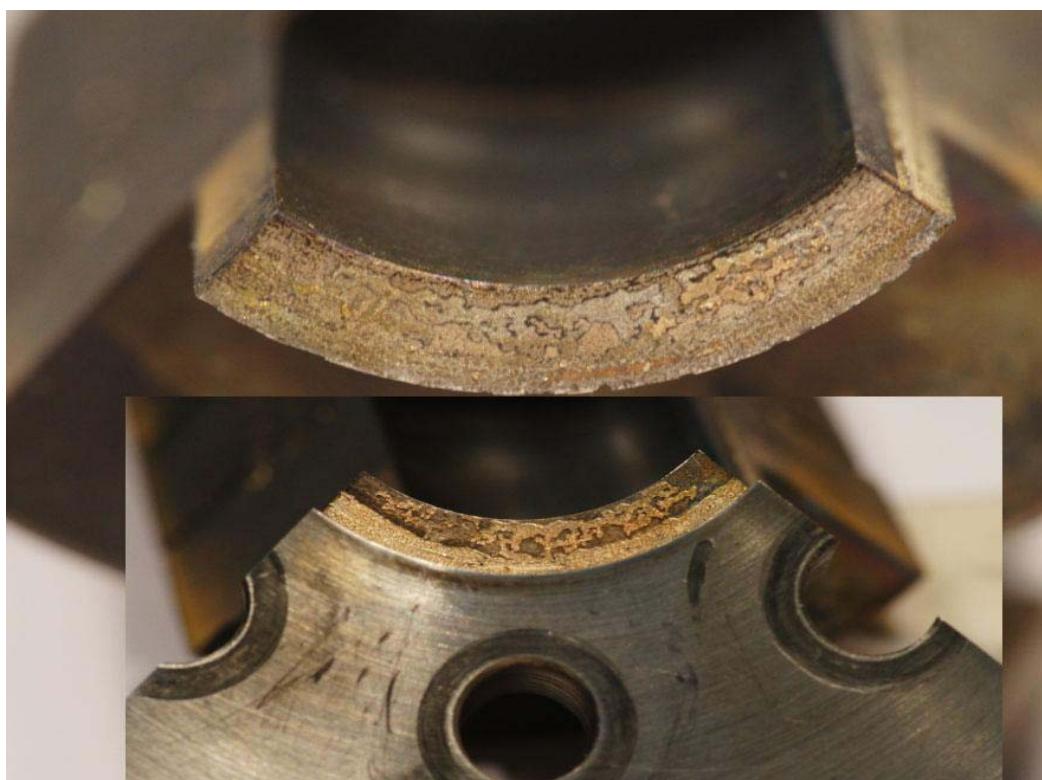
Fig 3 Highlight of joint failed in the right side of figure 2.

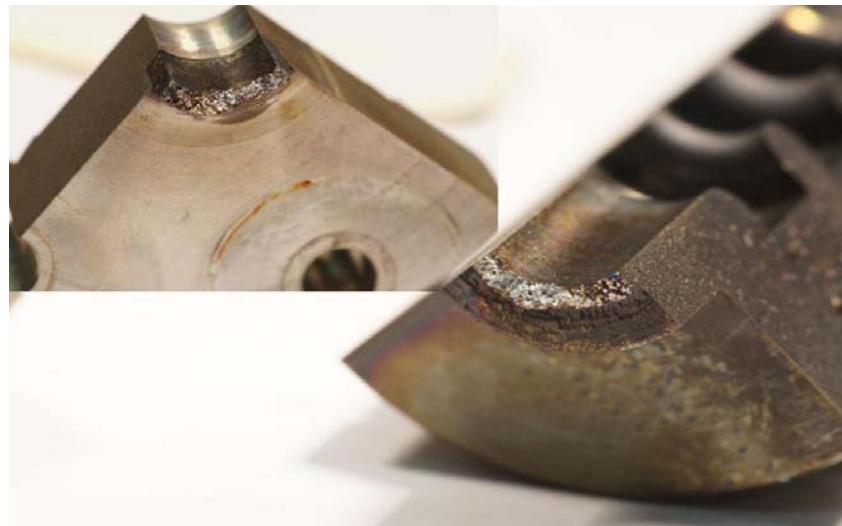
Fig 4 Highlight of molybdenum “extension tubes” failed adjacent to the SST flange in the left side of figure 2.

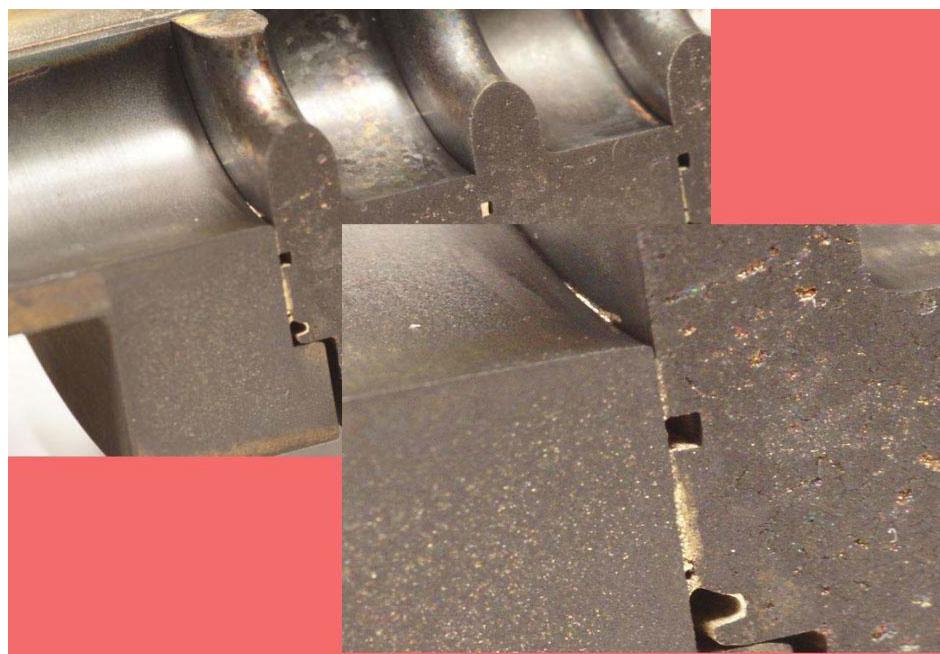
We think that the joins between structure cells could be improved by removing a void created by two contact surfaces on the iris side of the cell. This void is clearly visible on figure 6. The void could contribute to gas contamination and gas load during structure brazing and operation. For example, if inner contact surface has a vacuum leak and larger-diameter contact surface is vacuum tight, than this may adversely effect structure operation but would be hard to detect using conventional vacuum leak detection. By removing second-larger-diameter contacting surface we can improve contact between surfaces and avoid the uneven-alloy-filling of the joint seen on zoomed part of figure 6.

Fig.6 The image highlights a body/iris joint typical of moly structure.

We suggest a joint consisting of a single set of mating faces 1-3 mm wide between the body and iris. We may also use “nested” cells by creating a cylindrical step of ~1.5mm depth to lock the cells. The single mating surface will ensure contact at the cell-iris joint, would allow the cells to be made from much less material, and may significantly reduce the potential for contamination and virtual leaks. A multi-step braze sequence can be used to facilitate braze

fillet control. In the noted design the first step would be a diffusion bond or an “alloy assisted” diffusion bond, if the body material and desired temperatures and pressures prevent direct bonding. Alloy assisted bonding uses temperature and pressure to create a bond between both sides of a filler (a thin “washer” in this case) and the base materials. If proper surface finishes, materials, temperatures, and pressures are used the resulting bond should be leak tight with a well “filled” joint. The joint can then be brazed traditionally with a lower temperature alloy to provide additional strength.

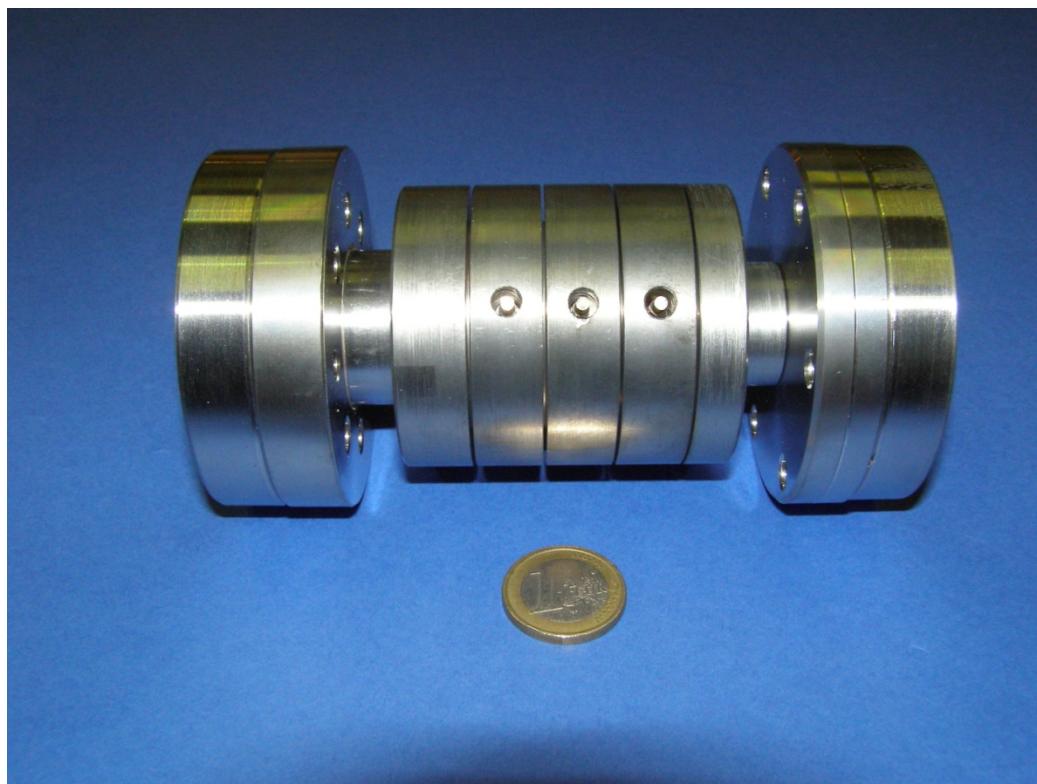
We also tried to make a new geometry of the joints surface to facilitate the brazing process, but again without results. In the figure 8 the assembled molybdenum structure is shown. Unfortunately the vacuum leak between the molybdenum and stainless steel right flange is again present.

The thermal treatments on the structure changed significantly the dimensions, especially in the conjunction area between molybdenum and stainless steel; in order to keep the initial dimensions the structure has been machined again and a new brazing process was attempted in order to close the vacuum leak at stainless steel flanges, but again without results.

Fig. 8 The assembled molybdenum structure.

The first structure realized at LNF following the same procedure gave good results [1]. This time several problems were occurred. Thermal treatments on the structure changed significantly its dimension, especially in the conjunction area between molybdenum and stainless steel; the deformations unfortunately are stochastic and no repeatable, and this could be due to the nature of the material (sintered metal). If so, the future of the bulk Mo structures is linked to the possibility to find on the market the proper Molybdenum. Obviously other ways (with low stress on Mo) can be tested for the connections. For example:1) Tin brazing procedure or 2) Electron beam welding.
