## **Technological aspects of construction molybdenum high gradient X-band standing wave accelerating structures**

### **Abstract**

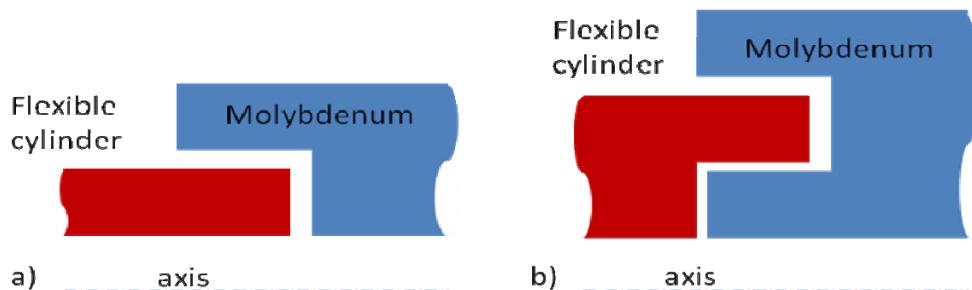
A possible solution that may reduce stresses caused by difference of thermal expansions could make use of an additional flexible part (in this case a cylinder) between molybdenum structure and SST flange. This thin-wall cylinder could be made out of stainless steel, CuNi, or copper and it should be properly designed to accommodate stresses created during the brazing. The joint between this flexible cylinder and molybdenum could be made with a groove that locks outside diameter of the cylinder as shown on figure 5a. This joint has to be properly designed to have adequate clearance when the parts are heated during the brazing. The design should also take into account thermally induced forces between the locking groove and the cylinder. The joint can be strengthened by locking not only outside diameter of the flexible cylinder, but also its inside diameter as shown on figure 5b. This, for example could be done for the flexible cylinder with large diameter.

Fig 4 Highlight of molybdenum “extension tubes” failed adjacent to the SST flange in the left side of figure 2.

Fig 5 Possible joint designs between molybdenum and a flexible cylinder: a) locking outside diameter of the flexible cylinder; b) locking both inside and outside diameters of the flexible cylinder.
