# T-980 Status

2008 Fermilab Crystal Collimation Workshop

Dean Still

# Status of T-980

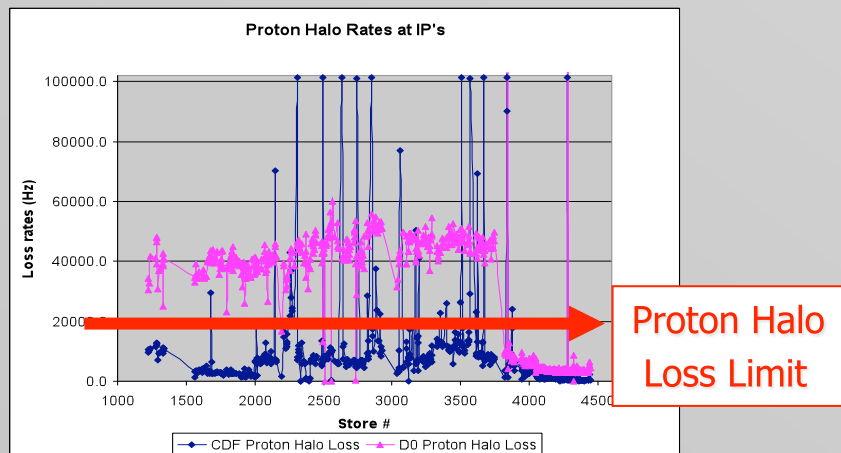
- Bent Crystal Collimation was used in the Tevatron for the first time.
- It was attempt to reduce halo losses at the IP's with growing Luminosity.
- Crystal Collimation system was installed at E0.
- Simulations predicted that a factor of 2 in proton halo reduction could be achieved compared to a tungsten target.

Crystal Collimation  
Installed at E0

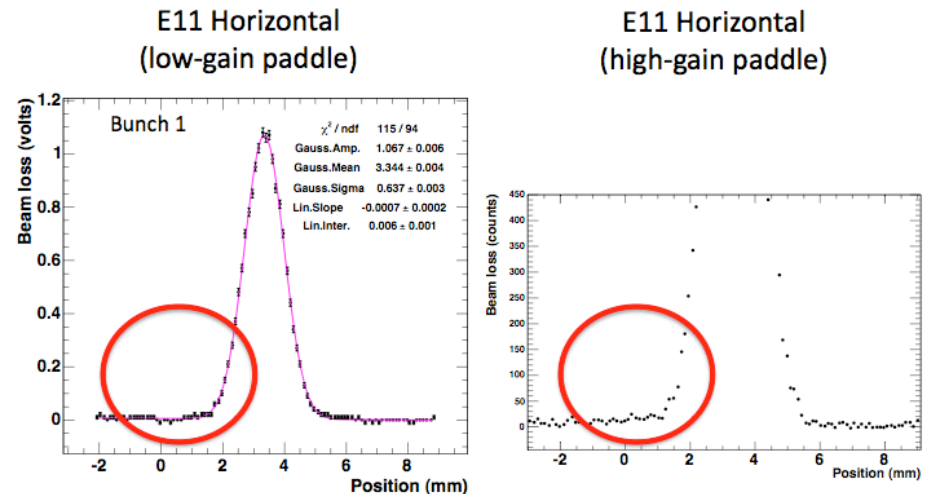
- Calibrate data from high-gain paddle (E11H) against that from low-gain paddle
- Study the growth rate of the beam halo using data from high-gain paddle

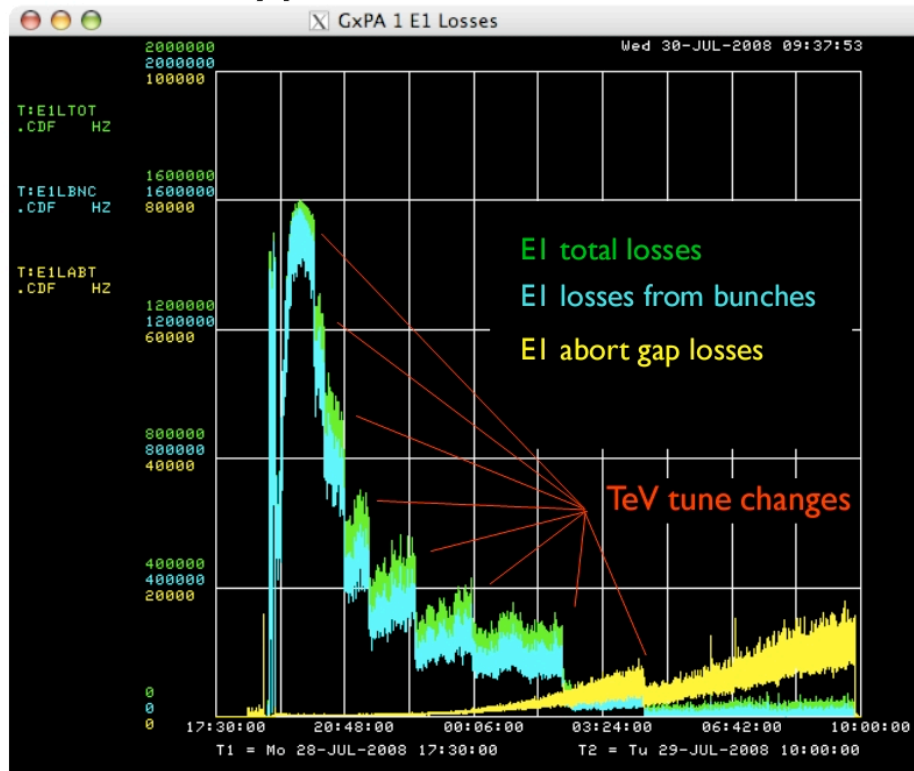
## EI Counter Performance typical store 6323

Regions of Interest

- no beam
- collimator out

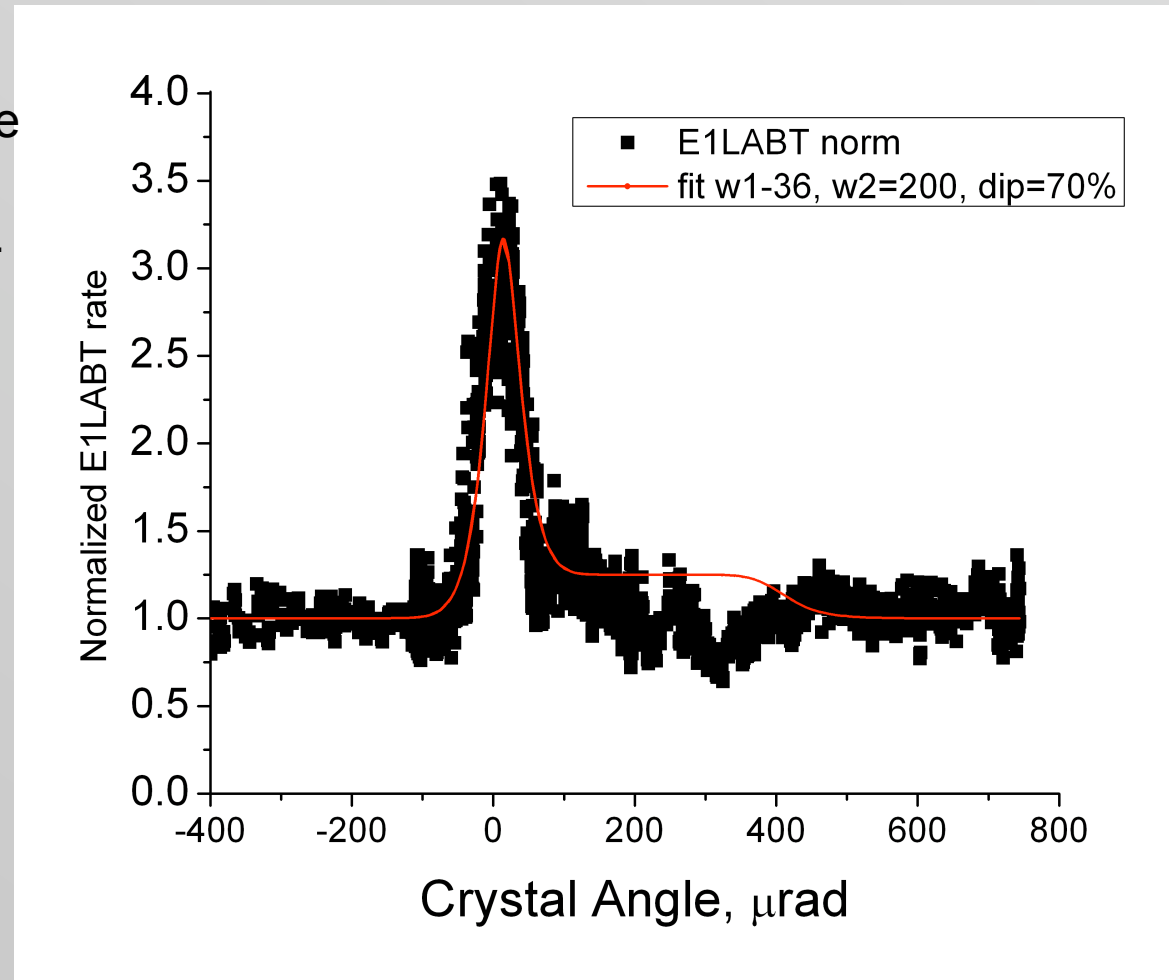
Fitting to the width of the abort gap beam that hits the E03H collimator again the Channel width is  $\sim 36$   $\mu\text{rad}$ .

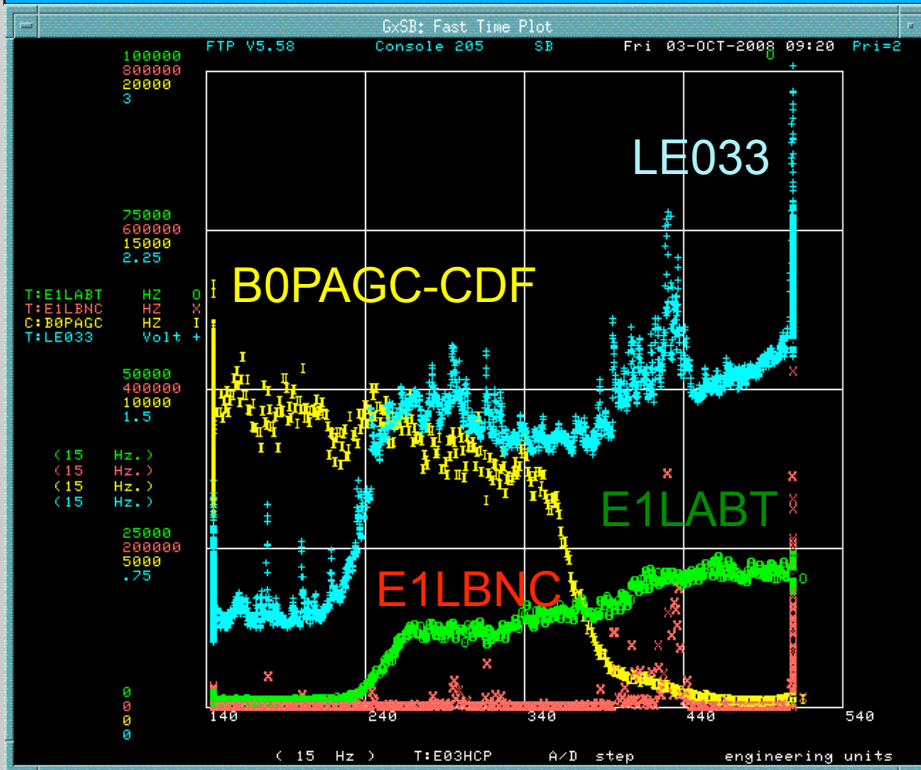
269 mil or 6.72mm

NOT 10.31mm for 410urad bend – Same result as 2005????

This has to be understood – It is believed that the large miscut angle may explain this. Attempting to simulate this effect.
